# EXTERNAL LEAKAGE MONITORING

### **EXTERNAL**

# LEAKAGE MONITORING

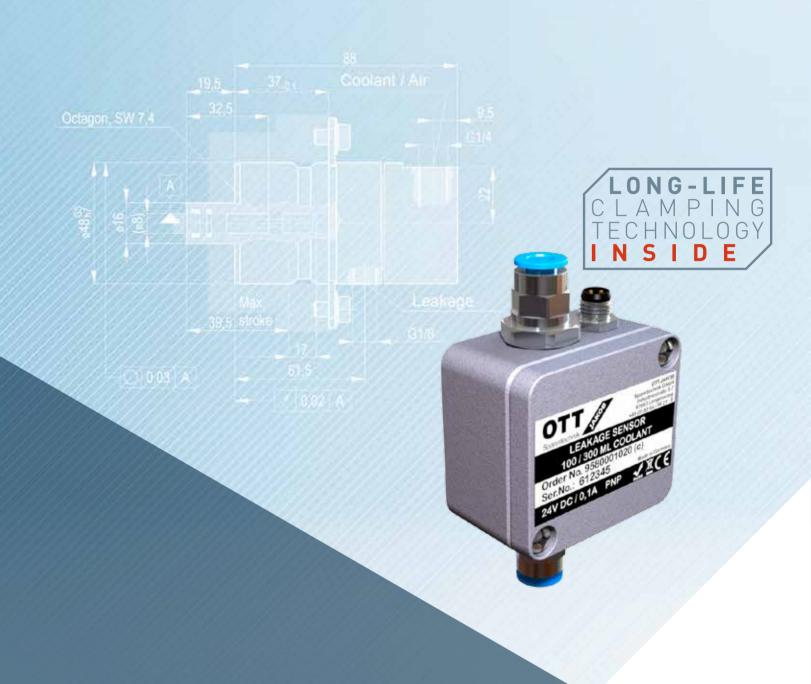
External leakage monitoring detects the presence of coolant or oil in the leakage tube.

With external leakage monitoring, the calorimetric sensor is positioned in a measuring device that is installed in the leakage drain of the rotary union.

If the programmable and predetermined flow limit is exceeded inside the tube, a signal is emitted which appears directly on the measuring device or which can be sent to the machine control unit. Two basic variants are available: for water-based and oil-based coolants.
